Coal Seam Fire

BURNED AREA EMERGENCY STABILIZATION AND REHABILITATION PLAN

White River National Forest

Bureau of Land Management, Glenwood Springs District

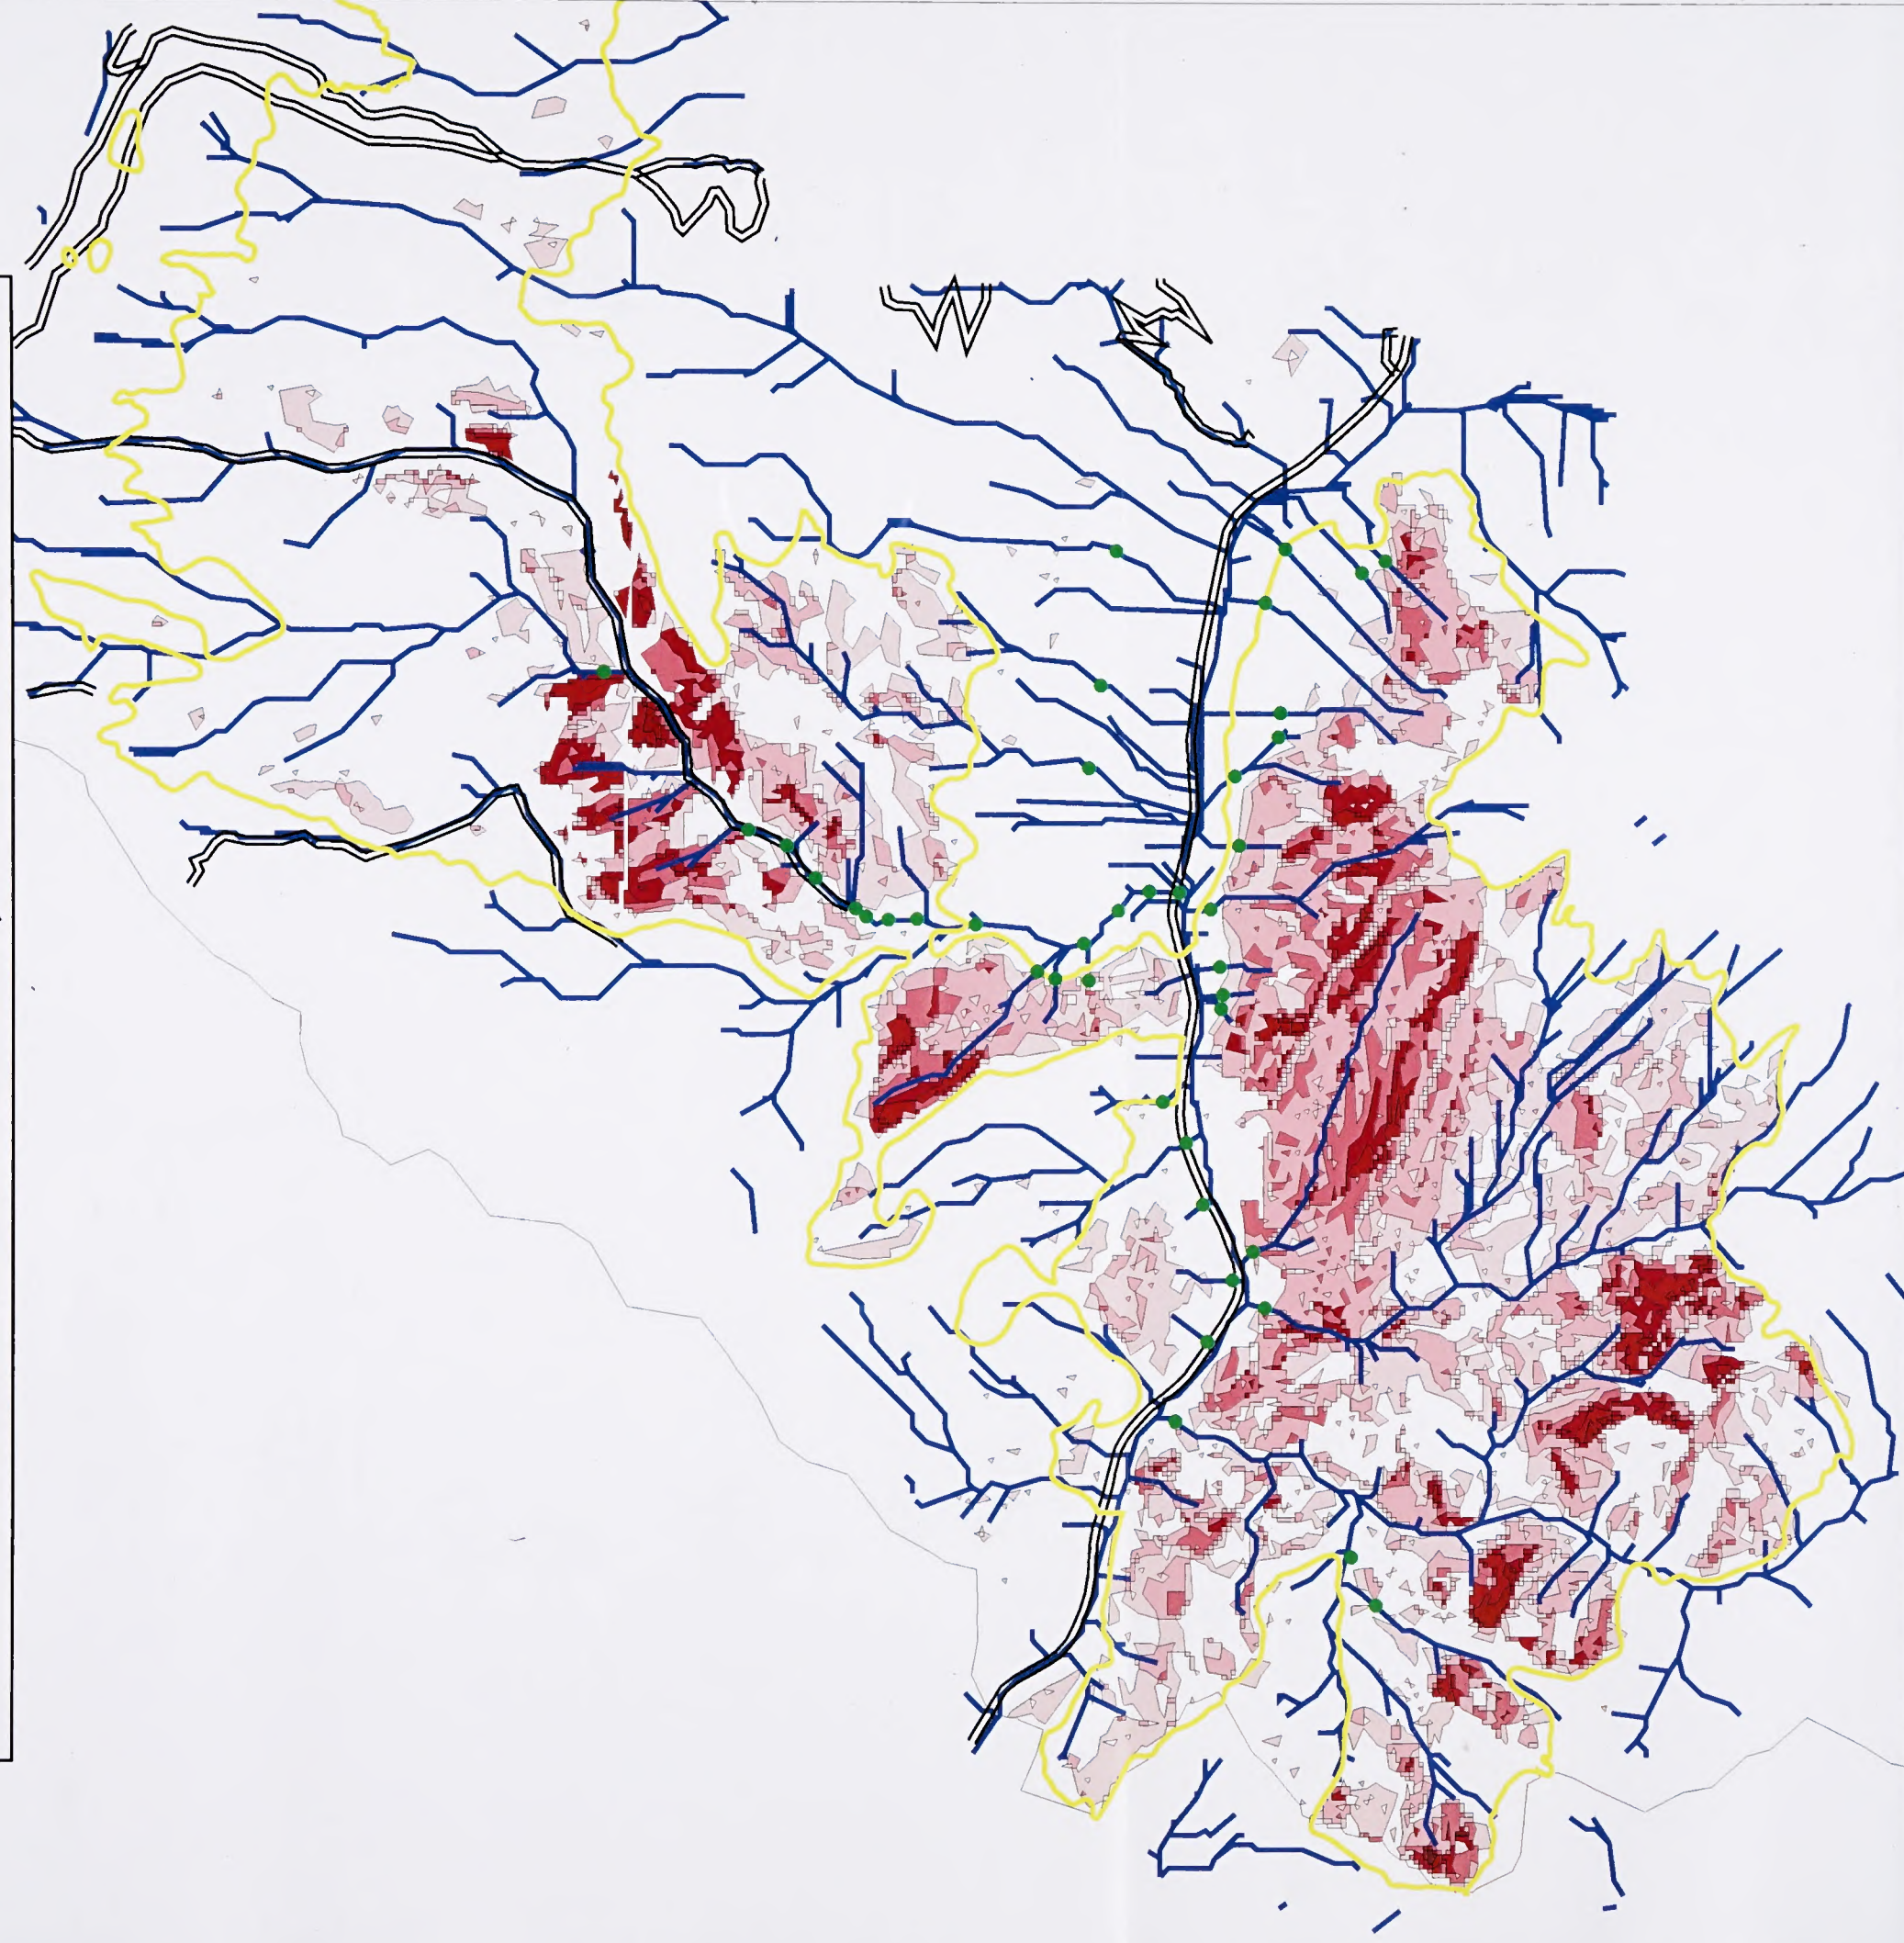
Change in Erosion Potential

(tons/acre)

*Modeled for a 10 yr/1 hr storm (1.05"/hr)

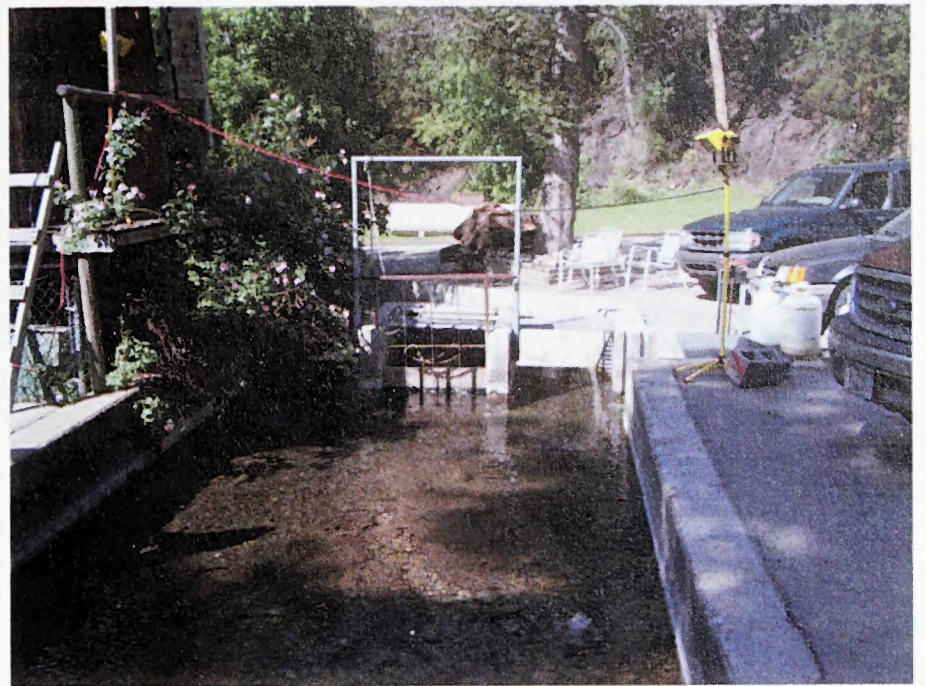
HATCHERY WEIR AND 30,000 GPM INTAKE

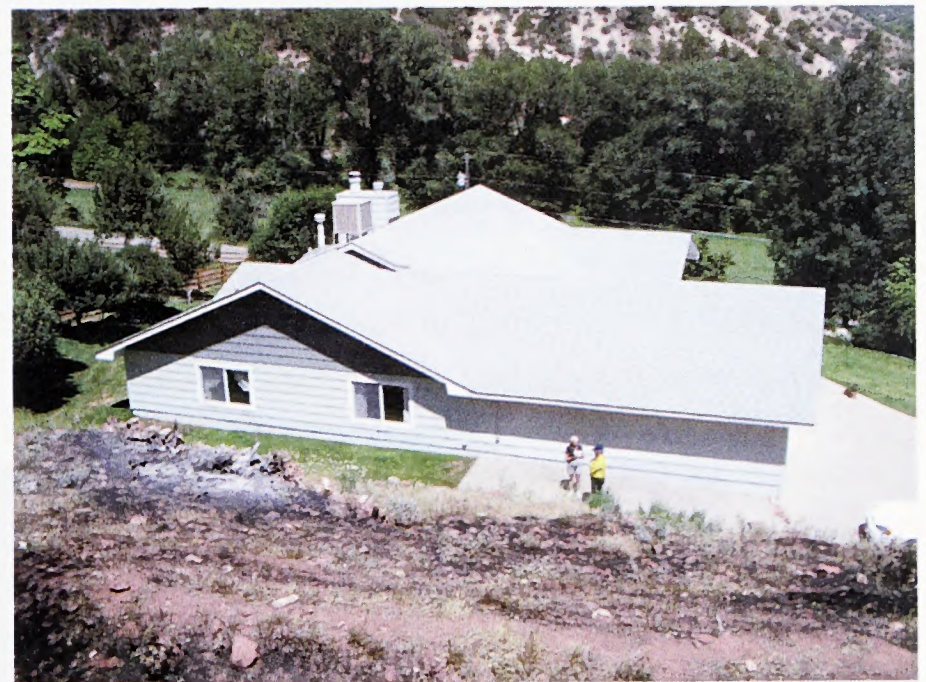
RESIDENCE ON WEST SIDE OF MITCHELL CREEK ROAD – DEBRIS FLOWS COULD DAMAGE THIS HOUSE.

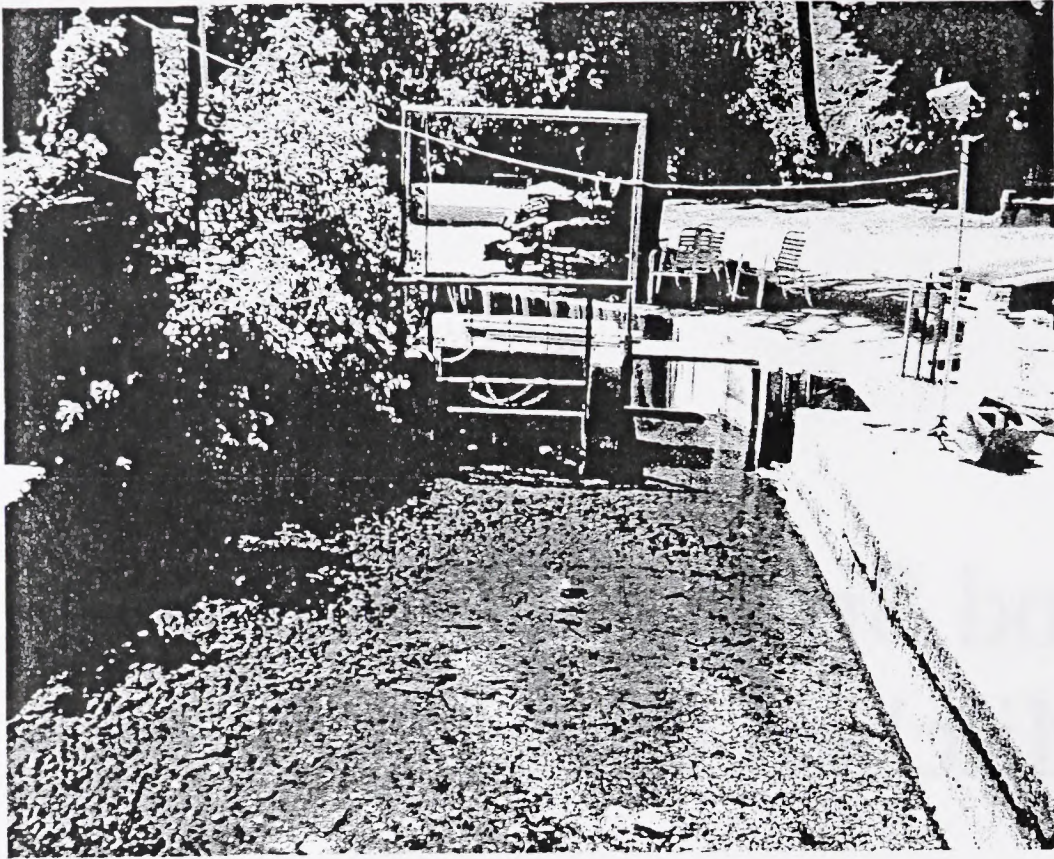
1. Diversion Structure

Note limited Freeboard
Sulkhead on @ ~ 2' high

This headgate allows for the diversion of Mitchell Creek water to bypass the raceways

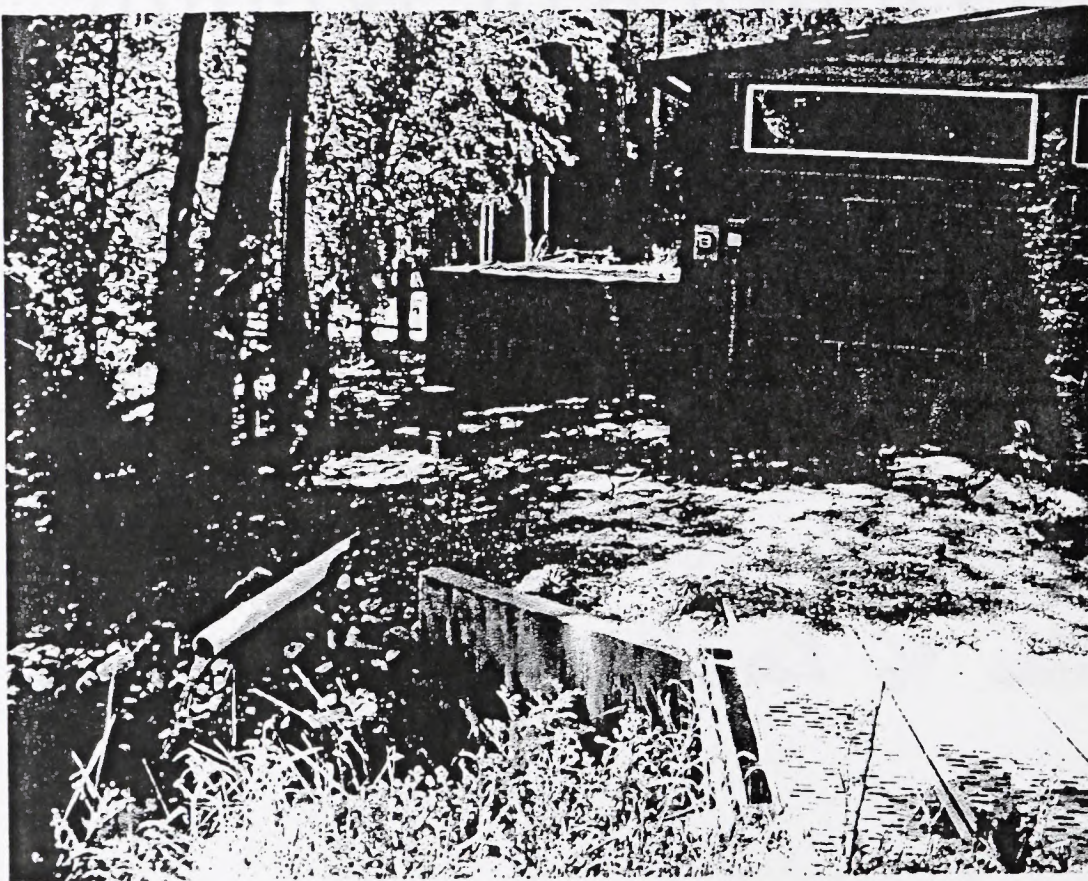
2. Quarantine Building

The structure at center contains UV decontamination units. Decontaminated water returns to Mitchell Creek via white pipe.

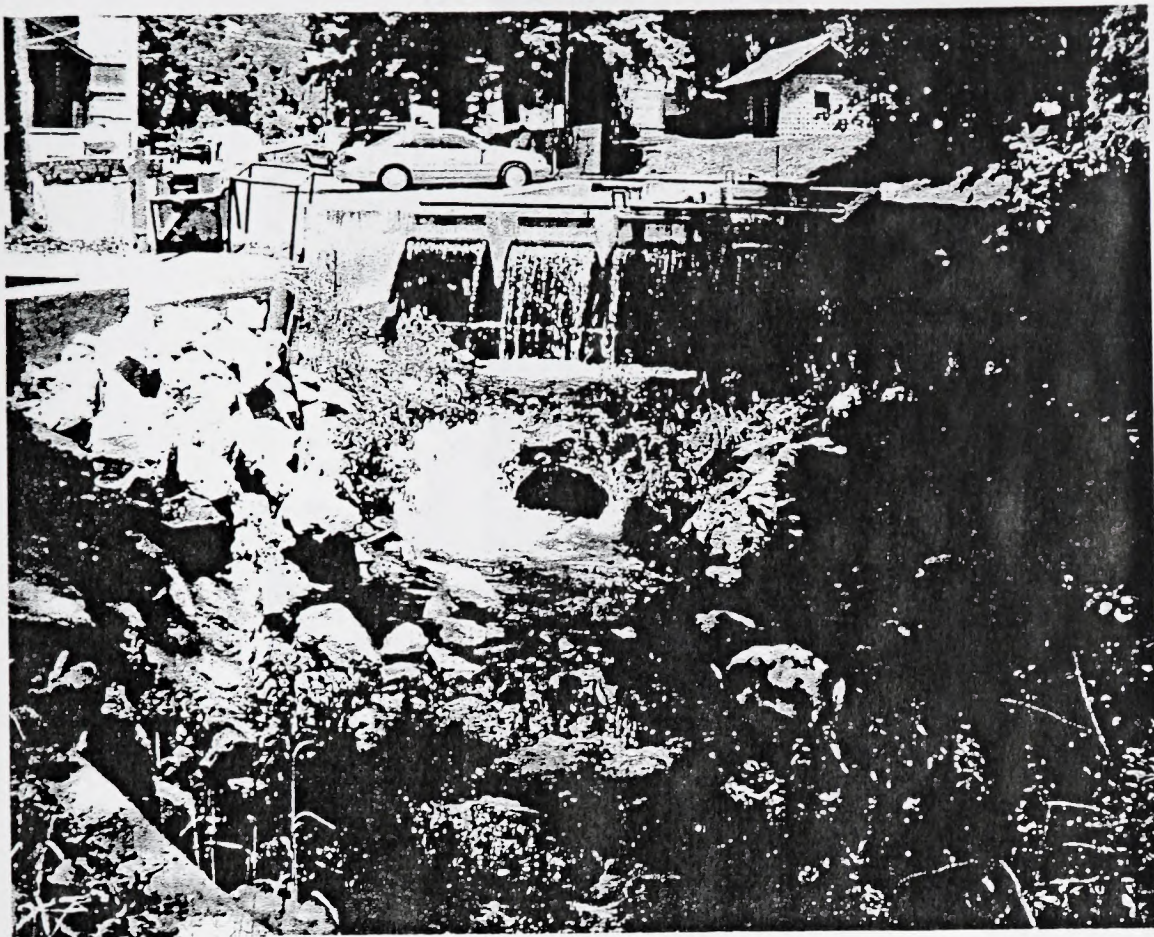
lower end of front raceways

3. Mitchell Creek water diverted at picture number 1, emerges through culvert at center of picture

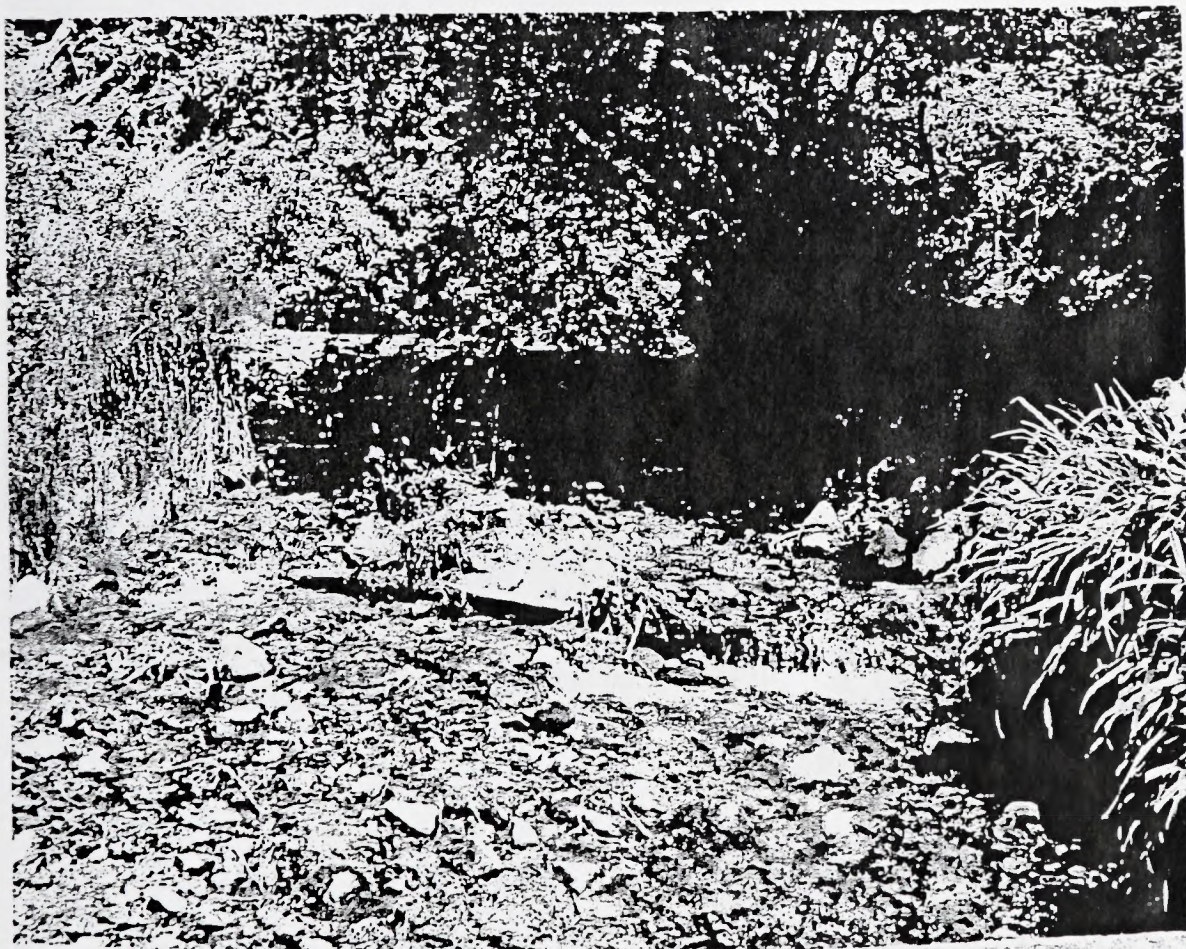
4. Mitchell Creek immediately above the hatchery.

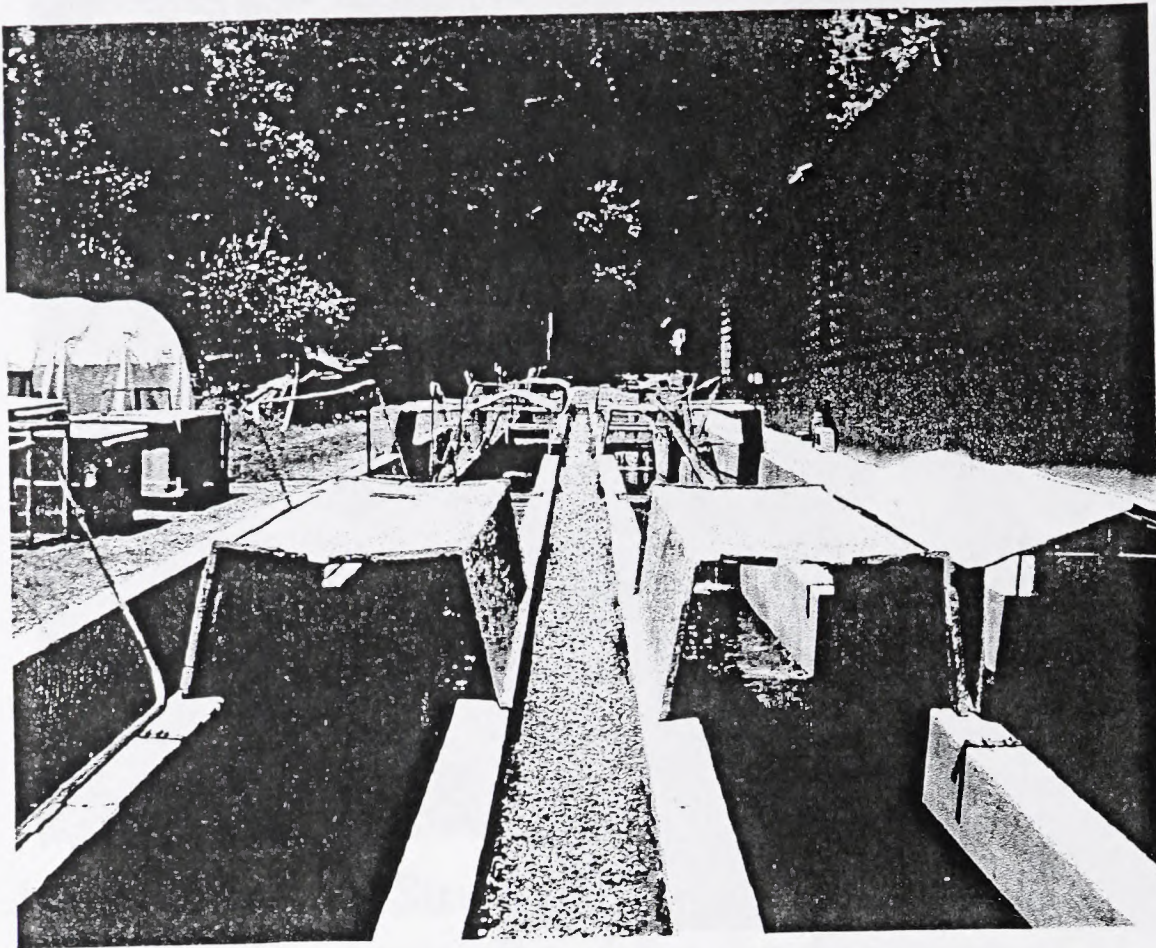
5. Nurse basins west of hatchery building.

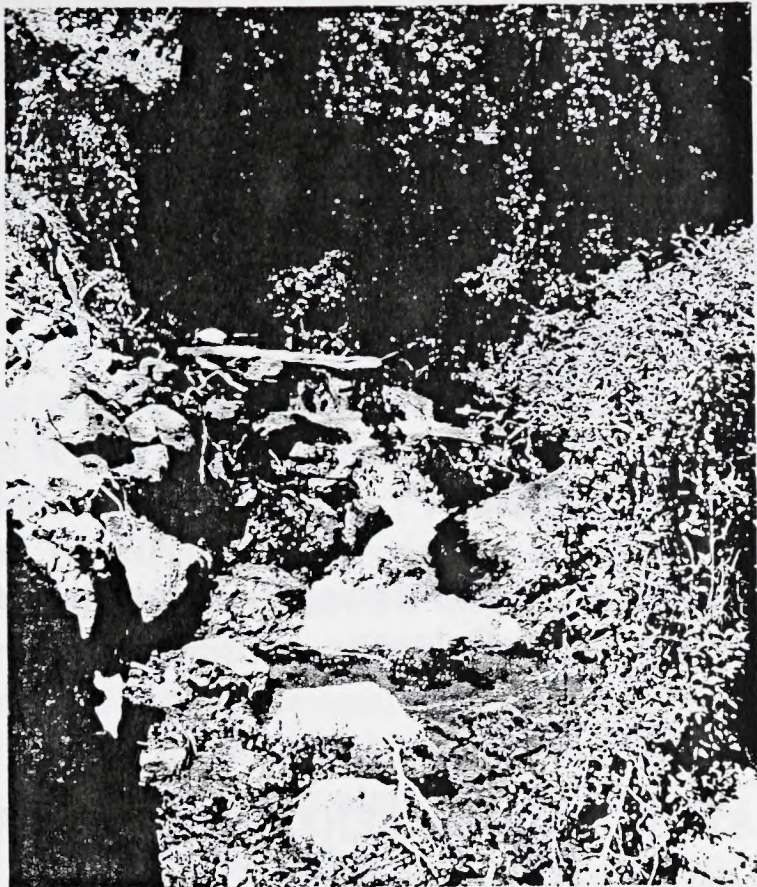
7. Mitchell Creek 100 yards above hatchery. Note thick, overhanging riparian vegetation and steep gradient.

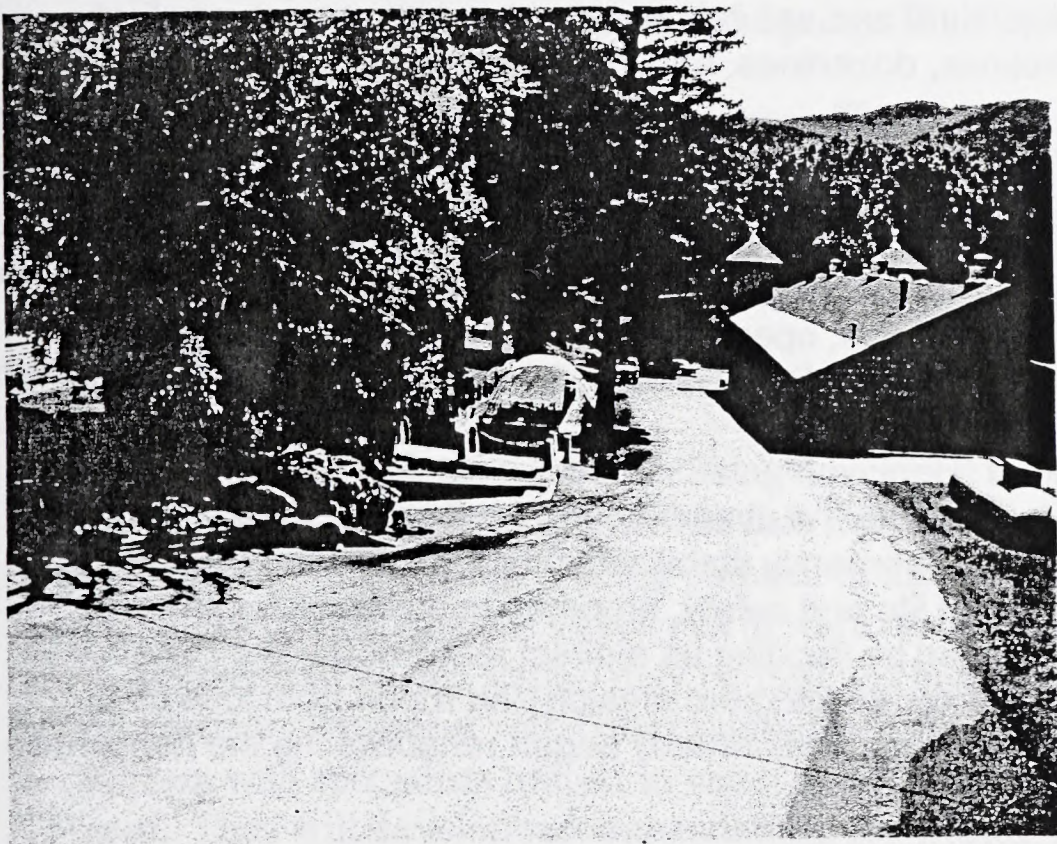
Looking downhill^(s) — creek diversion is out of picture to (L)

8. Front raceways (center) and hatchery building on right. Note there is no existing creek channel.

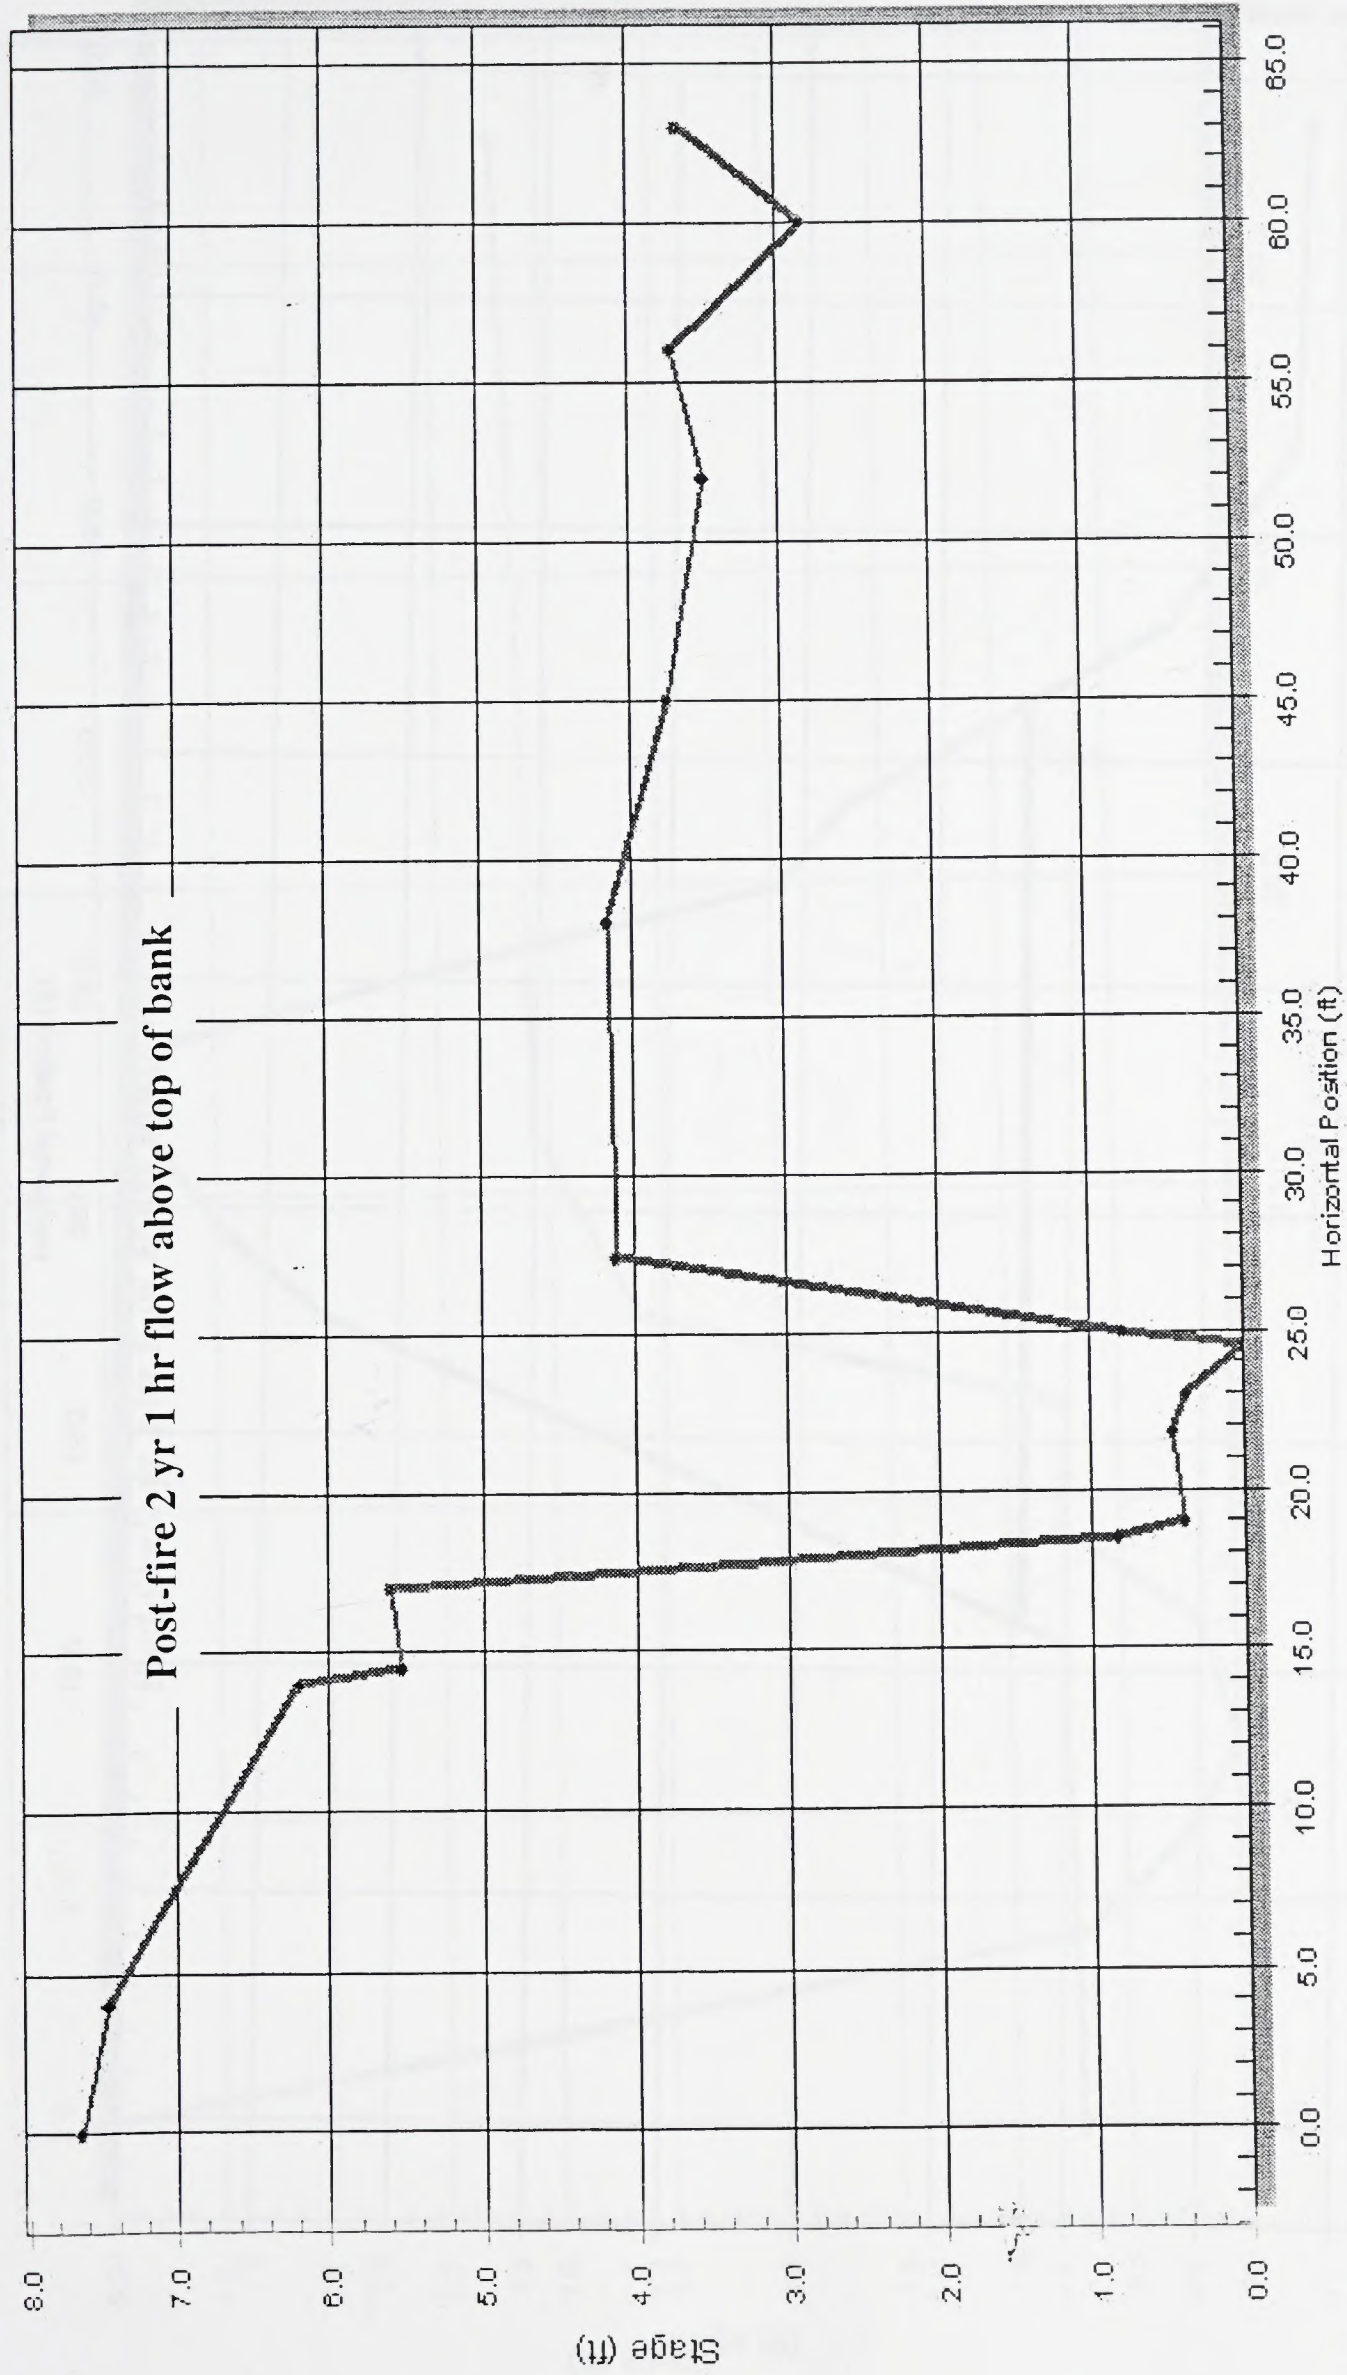
Cross Section 2 - Bridge at Unburned House Watershed

Xsection	Q at water level 6/20/02						Bankfull	Bankfull
	Stage	A	R	S	Q	n	stage	Q
1	0.8	2.69	0.38	0.0512	2.9	0.164	4.1	90
2	0.5	1.09	0.28	0.0394	2.9	0.048	7.0	1049
3	0.6	2.21	0.37	0.0907	2.9	0.176	2.6	75
4	1.2	5.40	0.57	0.0703	2.9	0.506	7.2	125
9	0.8	5.08	0.46	0.0203	2.9	0.222	2.4	44
10	0.8	4.31	0.36	0.0623	2.9	0.280	2.6	68

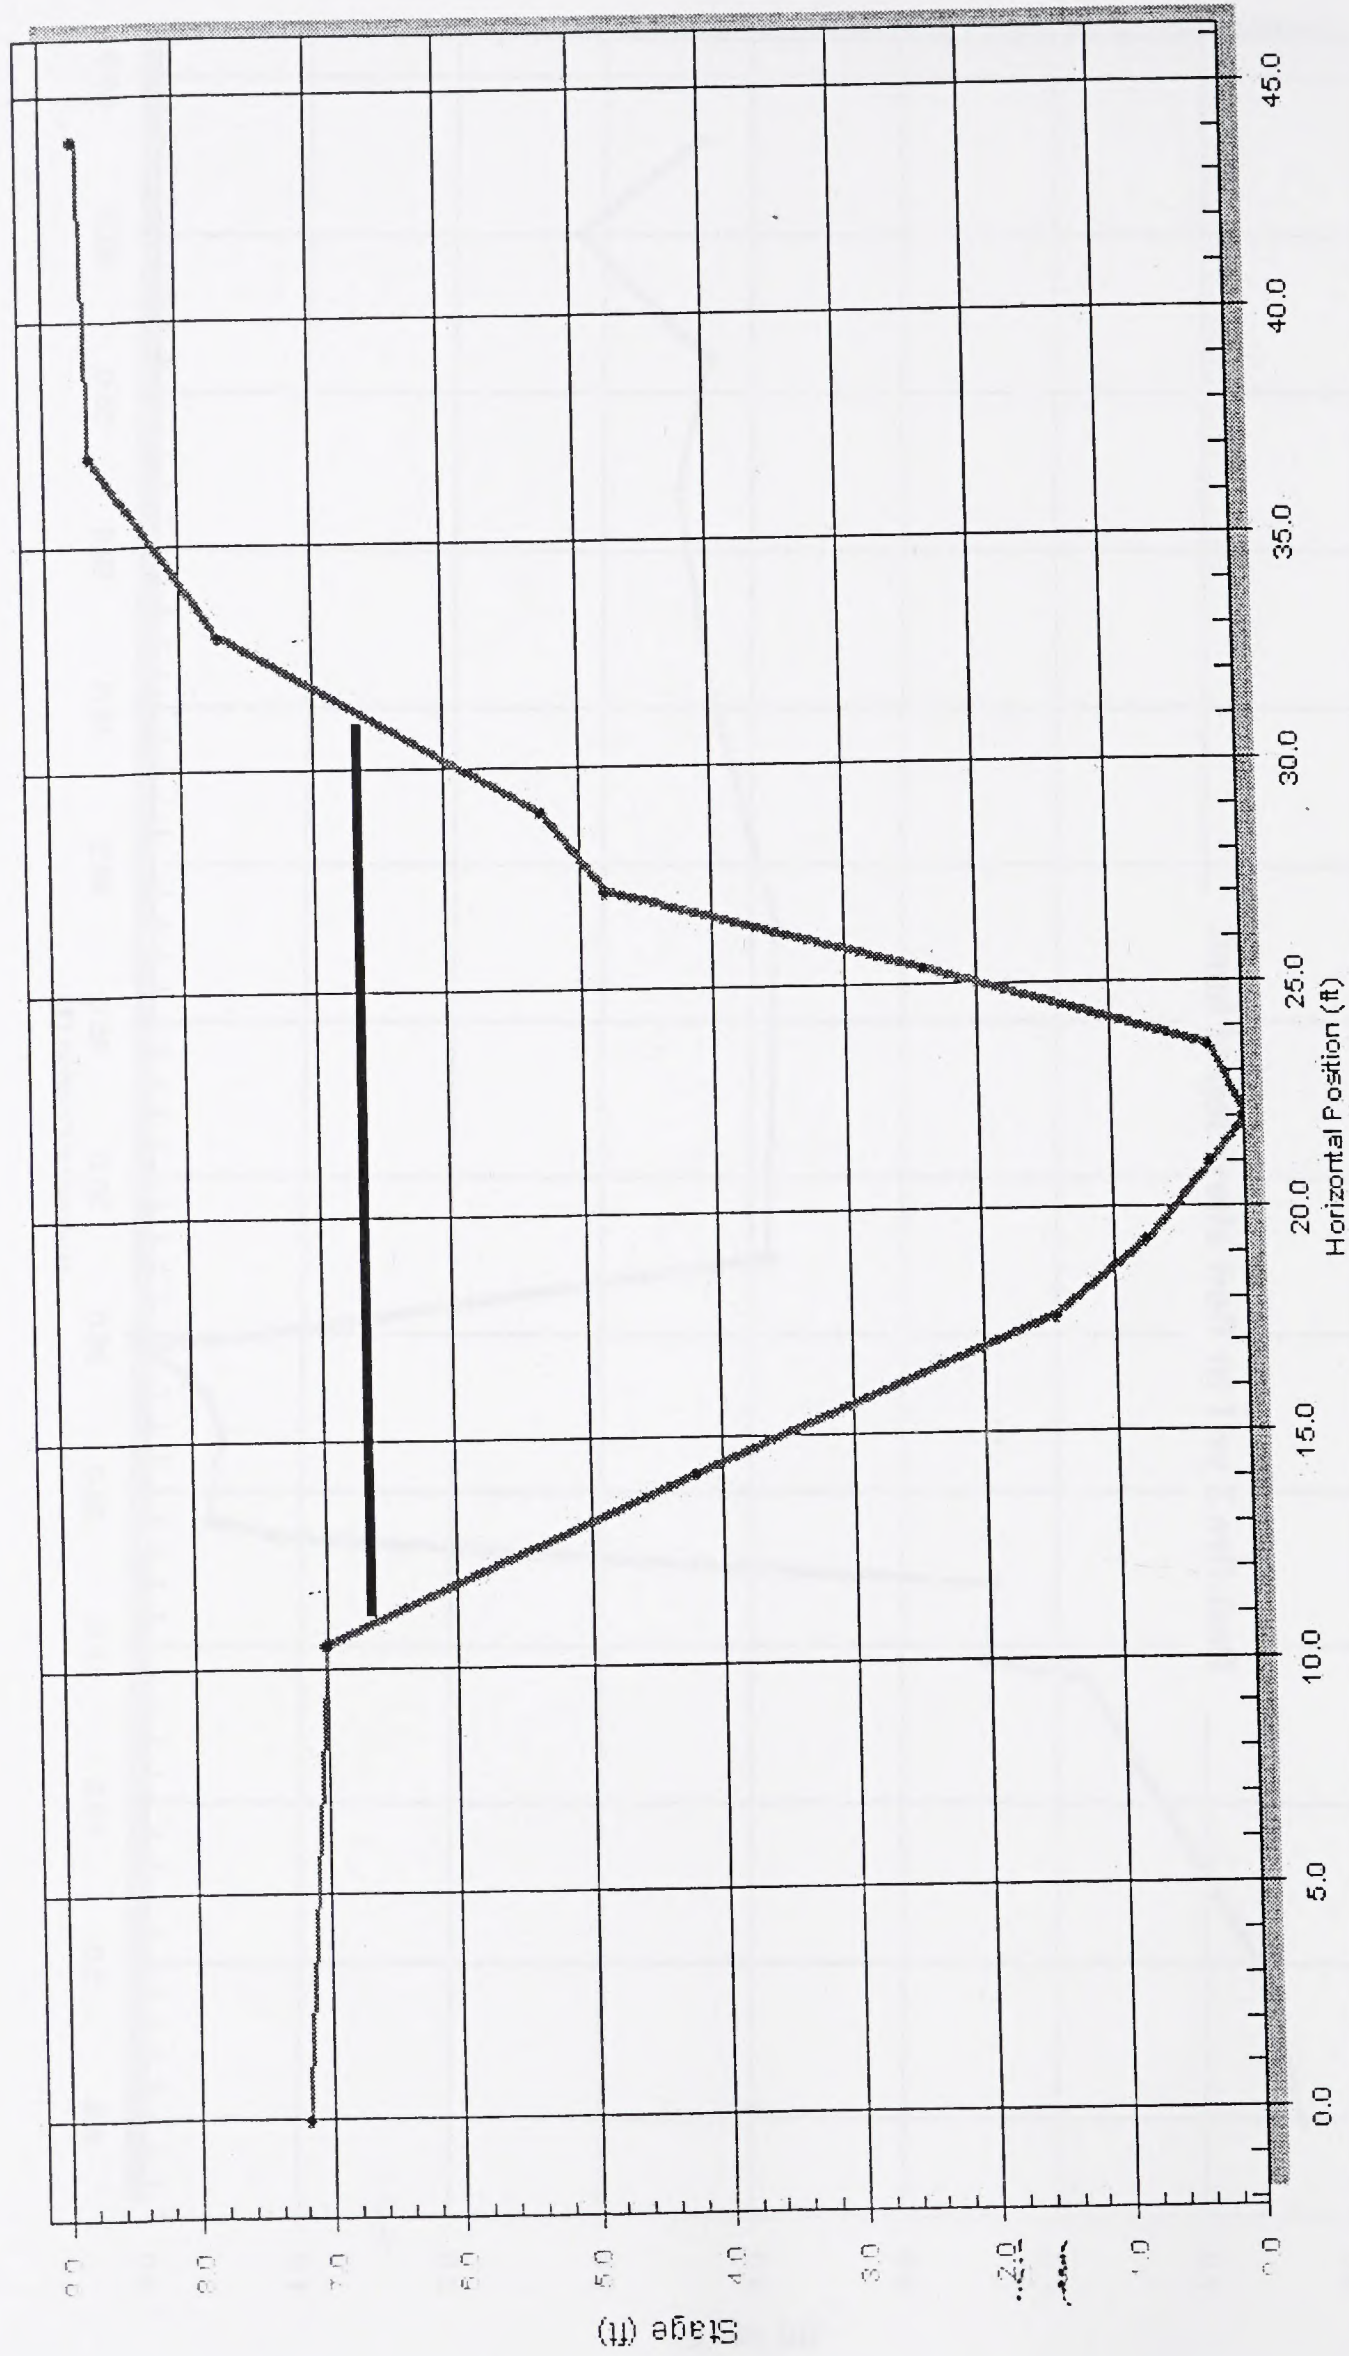
Cross Section 3 - Mitchell Road

Post-fire 2 yr 1 hr flow - 905 cfs
